Confidential Inspection Report Prepared For

933 Sample St.
Charlotte, NC 28204

March 29, 2019

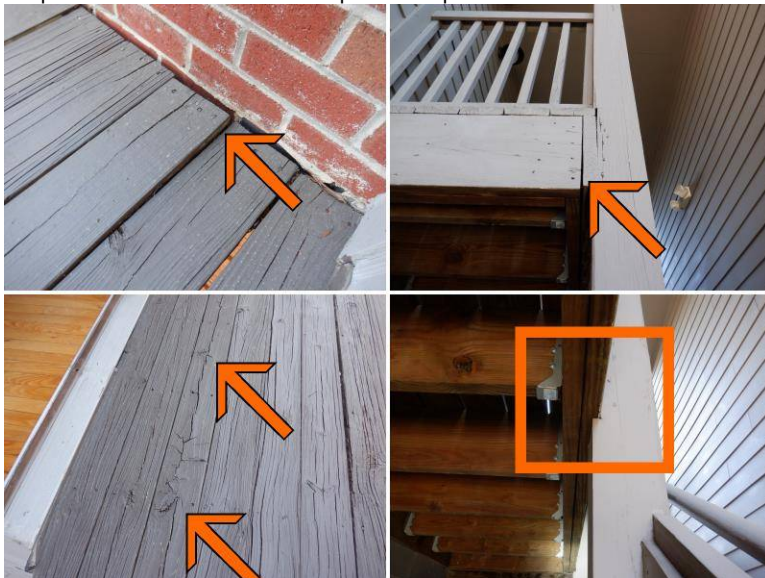
1. While the exterior is not included in the inspection, the following defects were found that could directly affect the unit. Have the association and/or a licensed contractor further evaluate and make correction as deemed necessary.

a) There were loose and cupping/bowing boards noted throughout the deck surface. The boards need to be secured properly and the cupping or bowing boards may need to be replaced.

b) There were cracking/deteriorating deck board at the balcony. Replace damaged/deteriorating boards to prevent further deterioration.

c) The decking at the front door walkway had separation at the girder along the right side and the girders only had partial bearing on the notches in the posts. Correction is needed to prevent separation or movement and ensure proper support at the posts.

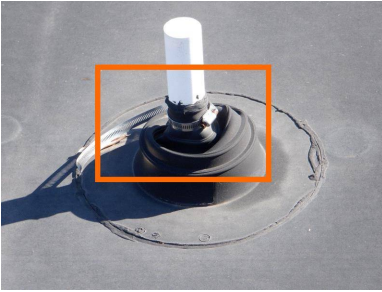
2. There were exhaust boot(s) that were found to be inverted at the time of inspection. Correction is needed to prevent the boot from holding water at the vent stack pipe and possibly leaking into the attic area.

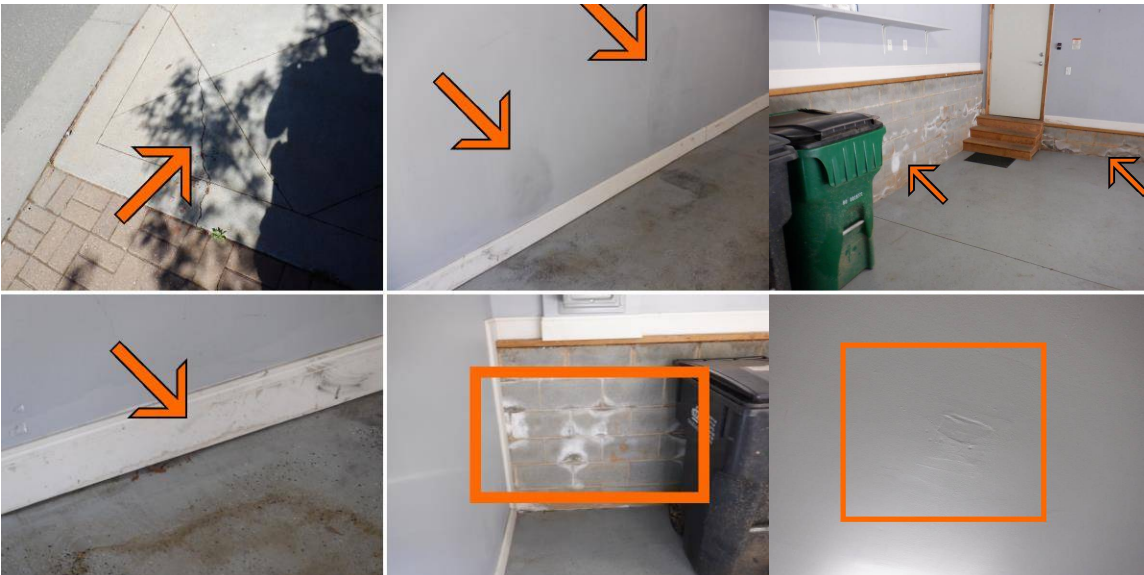
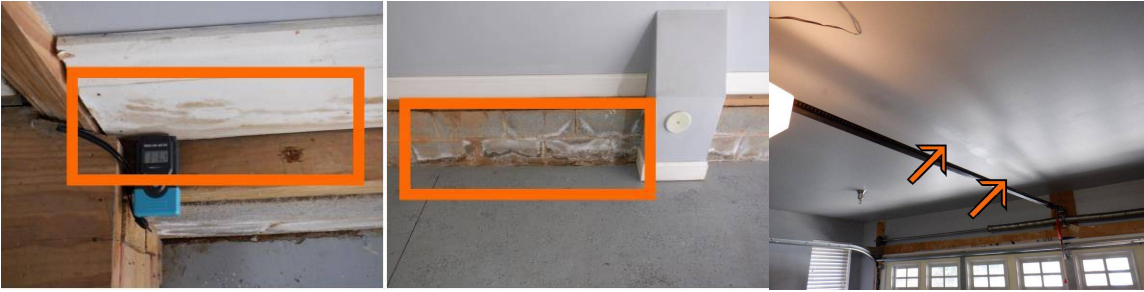
3. a) There was a crack noted at the driveway that need to be sealed and/or repaired properly to prevent water penetration and or continual cracking.
- b) There was water staining on the left wall of the garage. I was unable to determine the source of the stains. Ask the seller the history of the stains and repairs made. Continue to monitor and make correction if needed.

- c) There was efflorescence on the block walls at the rear and right side of the garage. This is an indication of water having passed through the wall. The darker coloring typically is an indication of an active intrusion. Correction is needed to prevent water intrusion through the wall and potential deterioration.

- d) There were 3 square repairs across the rear of the garage. I was unable to determine the reason for the repairs. Ask the seller the reason for the repairs to ensure posts had not been removed and make correction as needed.

- d) There was water staining on the baseboard around the garage side entry door. The stains were not wet at the time of the inspection. Continue to monitor and make correction as needed.

- e) There was a repair/stain on the ceiling above the garage door opener track. Ask the seller the history of the stain/repair. Continue to monitor and make correction as needed.

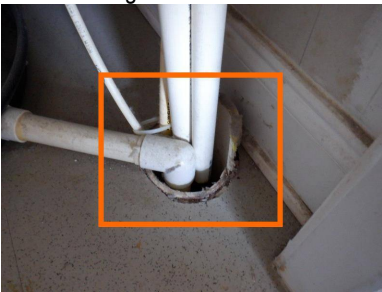
4. There was an open plumbing drain line in the utility closet for the drain lines for the water heater overflow and condensate lines. While this was a common practice, the pipe should be capped around the drain lines and or have a one way valve installed to prevent sewage back flow if the main drain line clogs.

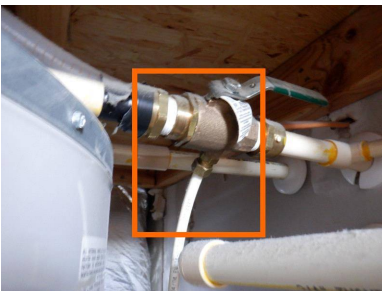
5. There was a valve installed in the piping above the water heater that was intended to be an expansion device, but these valves are not approved for that application. Have the valve replaced with an expansion tank to ensure proper protection against damage from water expansion. A qualified licensed contractor should be consulted to further evaluate and determine the full extent of the damage and/or if additional repairs are required or deemed necessary as there may be additional defects that were concealed and/or otherwise unseen at the time of the original inspection. Further evaluation is recommended before the close of escrow on the home, due diligence, and/or contingency period, whichever comes first, to completely understand the extent of the damage(s) and/or the full extent of the repairs that are needed, required, or deemed necessary by the qualified licensed contractor.

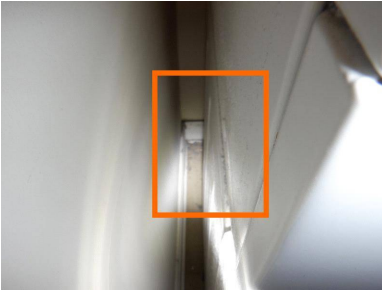
6. There was lint on the floor behind the laundry machines. Due to the tightness of the closet, the back of the units was not visible. Have the dryer vent hose and attachment checked to ensure lint and moisture are not leaking behind the units.

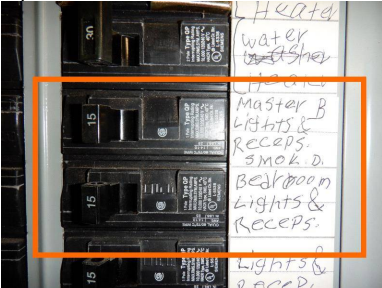
7. There were no AFCI breakers in the panel to protect the bedrooms from a hazard if there was any arcing in the walls. Have the breakers replaced with AFCI breakers to ensure safety. Have a licensed electrical contractor evaluate and make correction as needed.

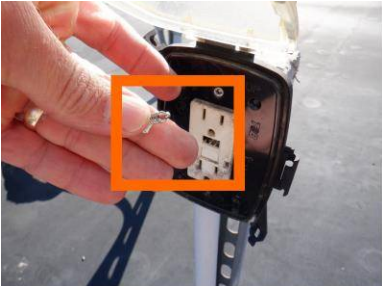
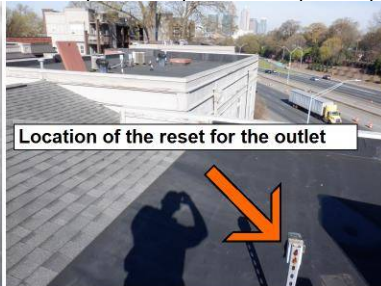
8. a) There was an outlet on the roof next to the AC unit. When it was tested for GFCI protection, the outlet on the roof of the unit to the right tripped and the button shot out. The outlet should be replaced to prevent the pieces potentially being lost if the outlet trips.

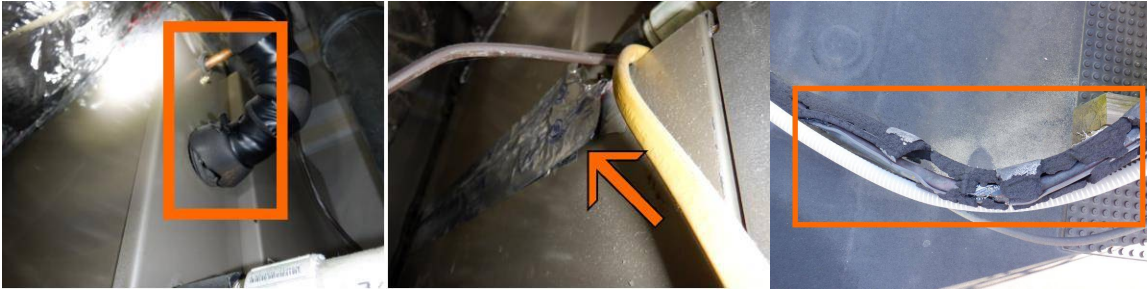
b) There was loose tape on the furnace/evaporator coil. Correction is needed to prevent air leakage.

c) The insulation was damaged, deteriorated, and/or torn and needs replacement to prevent the Freon line from sweating and/or causing possible damage to the unit. Keeping the Freon line insulated is a vital part of the system. It carries the coolant as a gas and this line should be insulated the entire length to help prevent the coolant from heating up due to the exterior temperature, preventing it from changing to liquid which would ultimately cause damage to the unit.

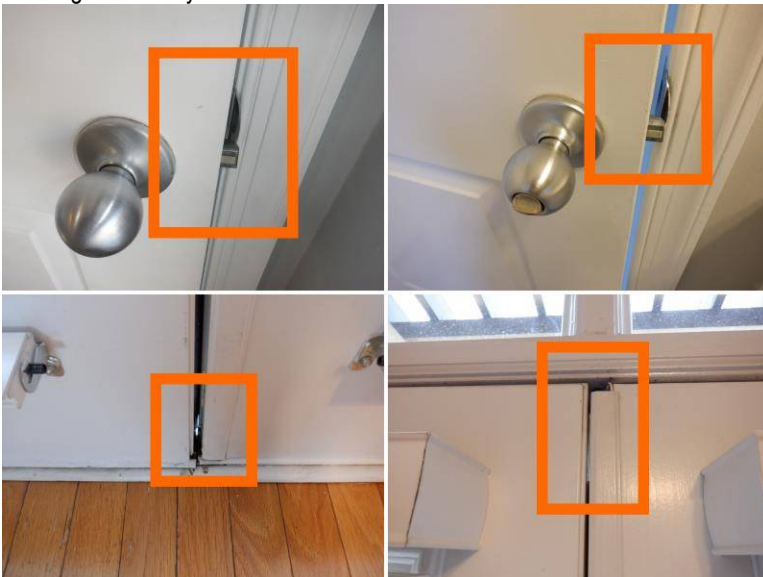
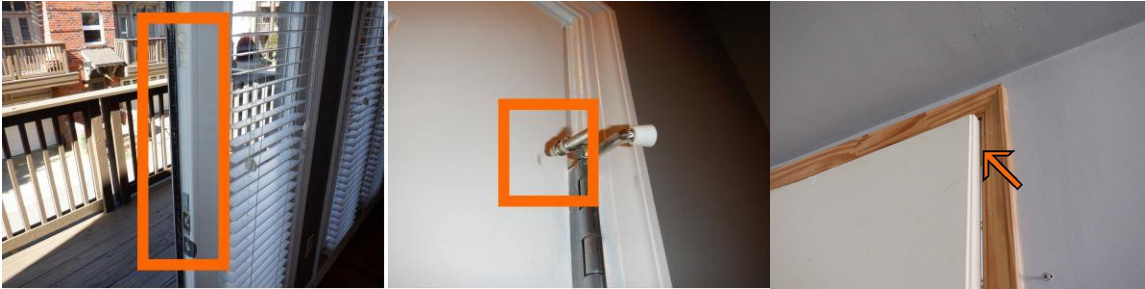
10. a) There were door stops missing/damaged behind doors in areas throughout the home. Replacement needed to prevent possible damage to the walls behind the doors.

d) The section of the living room exterior doors with the strike plates shifted when the upper lock was unlocked and locked. Correction is needed to secure the section to prevent movement, damage, or misalignment of the plates.

e) The following door(s) listed below were found to rub at the top and need adjustment and/or repair for the door(s) to open and close properly without rubbing:

- Garage side entry door

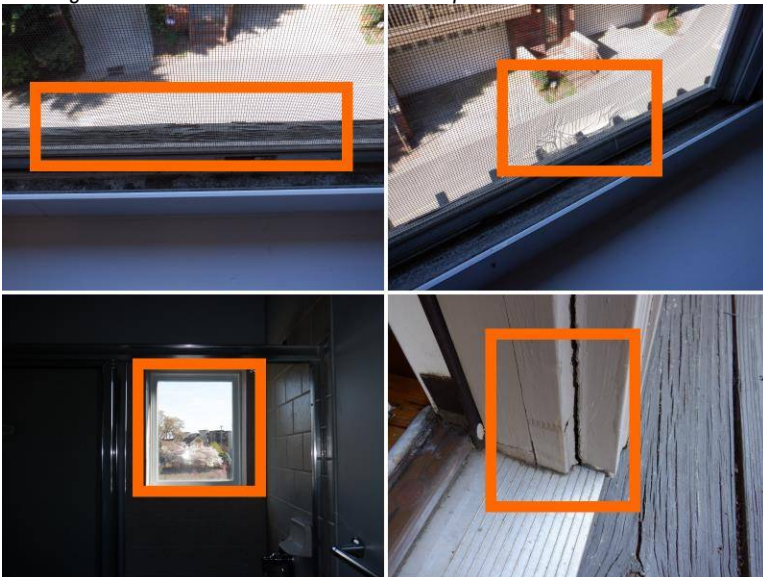
11. a) There was exposed wood on the trim around the outside of the unit. While the exterior is not included in the inspection, the exposed wood could affect the interior if there is wood rot that could allow water intrusion. Have the association make correction to the wood trim to prevent water intrusion and further deterioration.

b) The window screens were noted to be missing and/or damaged at or on windows around the home at the time of inspection. Correction is needed to prevent insect intrusion.

c) The following window(s) and/or sashes (but not limited to) were found to have a bad or broken thermal seal:

- Master bathroom window

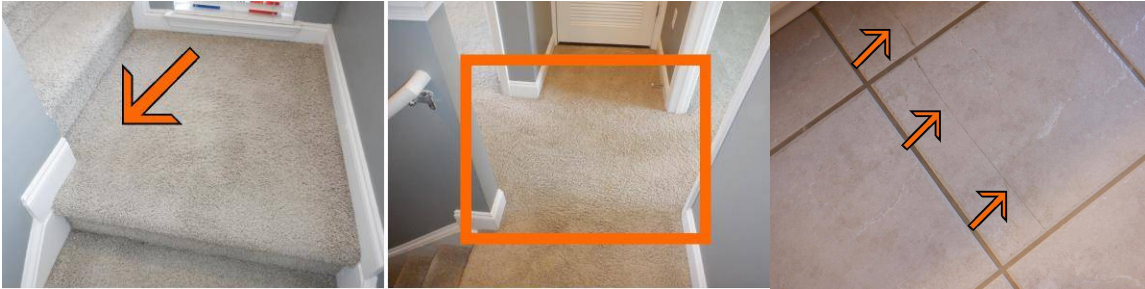
12. a) There were areas of the floor in the unit that the floor was sloped or dipped. I was unable to determine the cause of the uneven floors. Continue to monitor for signs of movement and make correction as needed.

b) There was cracking in the tile floor in the master bathroom. Continue to monitor and make correction if needed.

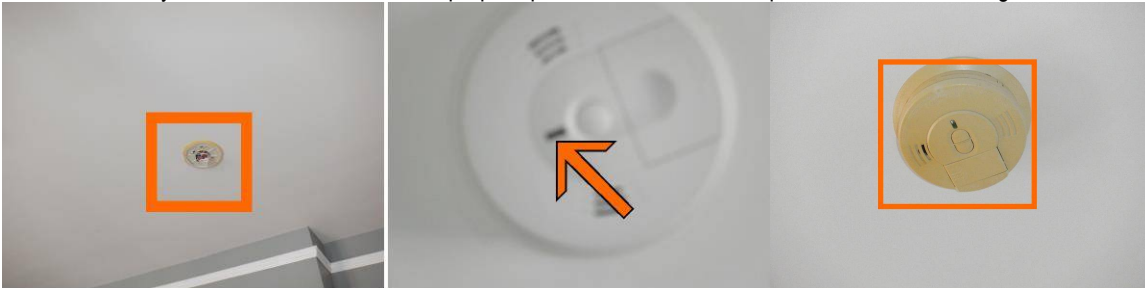
13. a) There were smoke detector(s) that were found to be missing throughout the home at the time of inspection. Replacement is needed to ensure safety. Have a qualified licensed contractor further evaluate all the smoke detectors installed in the home and repair or replace as needed to ensure that they are all functioning properly.

- Downstairs unit (The detector was in the kitchen drawer)

b) The detectors in the unit were wired, but the newer unit in the rear bedroom was not plugged into the electricity and was operating on battery only. This detector was a CO/smoke combo unit. Typically, the CO unit is located in the hall to service all the bedrooms. Have the CO unit moved to the hall and ensure it connects to the wires so that all detectors sound as one if any of them are set off.

c) There were older yellowing detectors in the unit. The yellowing plastic indicates the detectors are older and they should be replaced as recommended by the manufacturer to ensure proper operation as dust builds up over time and can clog the sensors.

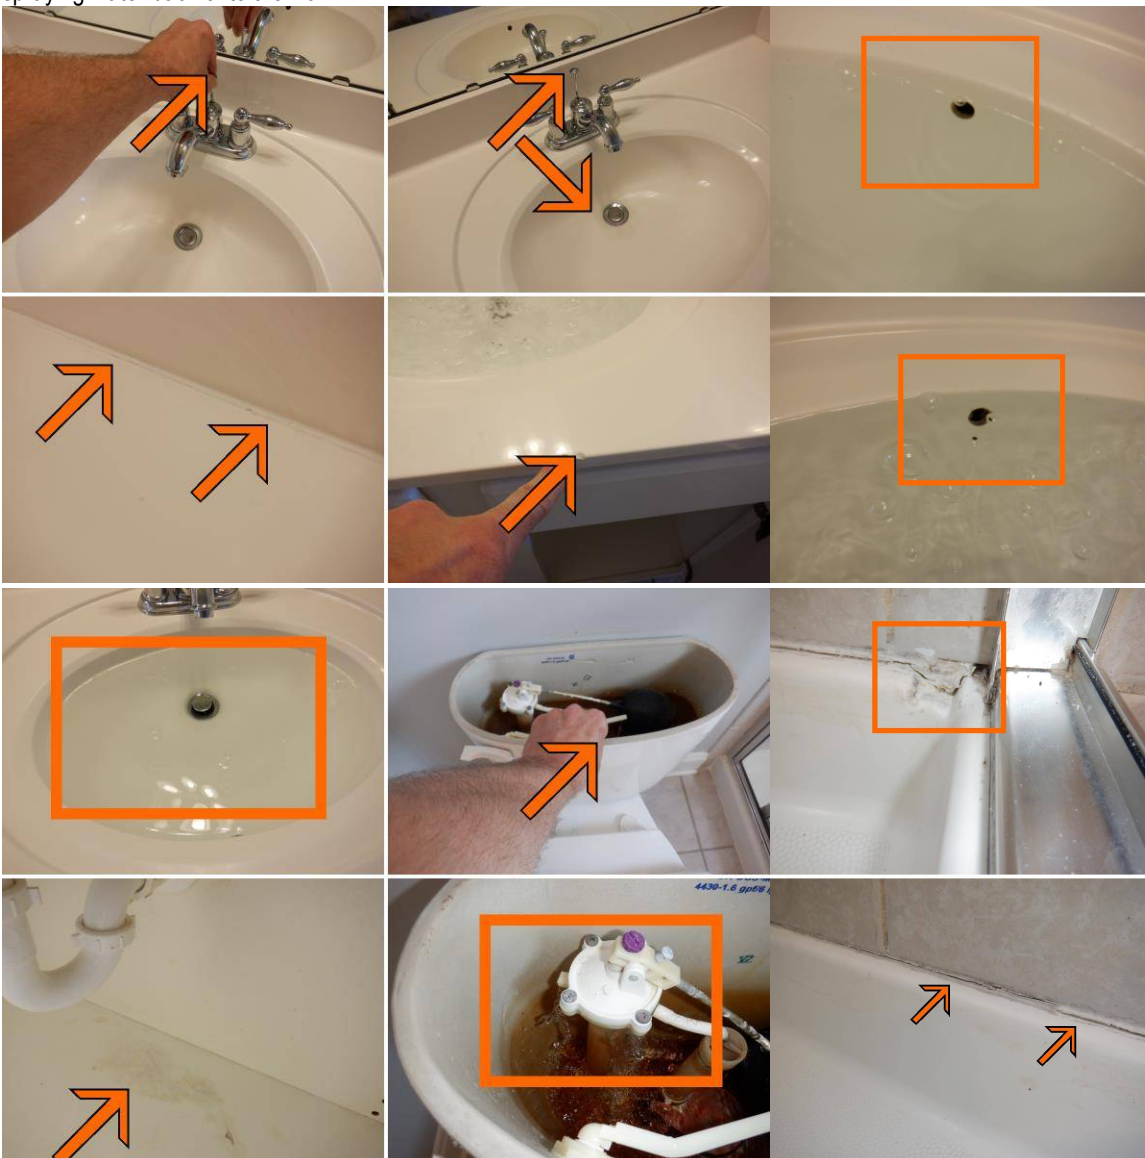
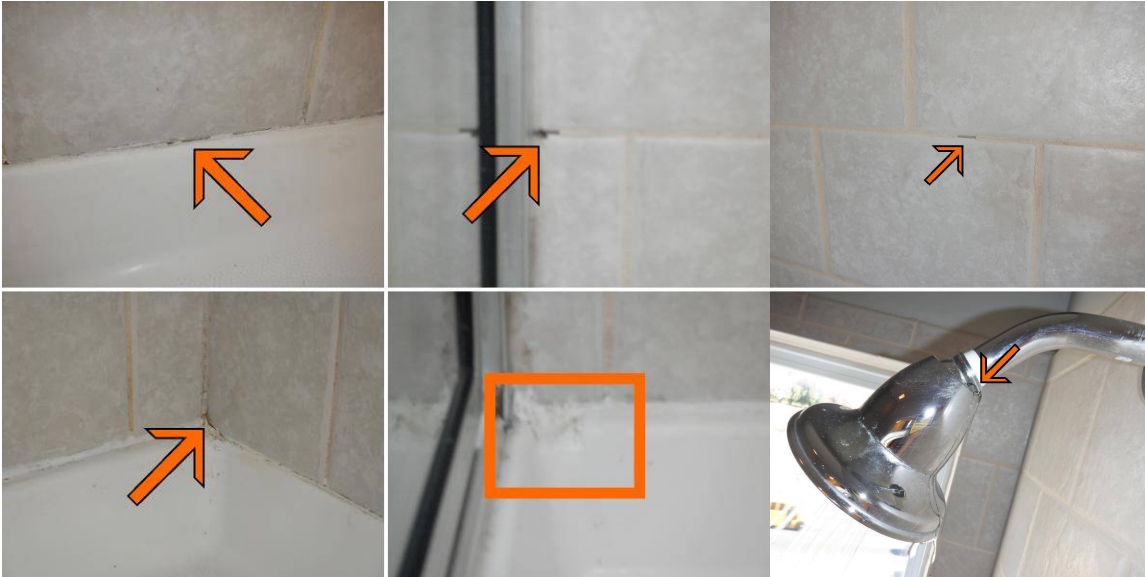
14. Due to the following but not limited to the listed items below, repairs and/or corrections were needed within the **master bathroom area**. A qualified licensed contractor should be consulted to further evaluate and determine the full extent of the damage and/or if additional repairs are required or deemed necessary as there may be additional defects that were concealed and/or otherwise unseen at the time of the original inspection. Further evaluation is recommended before the close of escrow on the home to completely understand the extent of the damage(s) and the full extent of the repairs that are needed, required, or deemed necessary by the qualified licensed contractor.

d) There was a chip in the edge of the counter near the left sink. Continue to monitor for further deterioration and make correction if needed.

- g) There was evidence of prior leaking under the right sink. No active leaking was noted during testing. Continue to monitor and make correction if needed.

- h) The tank was loose where it attaches to the base of the toilet and needs to be properly secured to prevent leakage.
- i) The fill valve was bad and needs repair/replacement. Water should only exit through the rubber hose at the middle of the tank or down the provided pipe on the side depending on the type of fill valve you have. Water should not spray out around the top gasket of the valve this indicates a bad gasket and is not functioning properly. Repair or replacement needed to allow proper operation.

- j) The weep holes at the base of the shower wall have been sealed. These holes should be left unsealed to prevent water being trapped in the wall.
- k) Several areas in the tub/shower surround that were noted in need of additional grout or re-grouting to be sealed properly and prevent water penetration.

- l) There was a leak noted at the back of the shower head where it connects to the plumbing pipe. Correction is needed to prevent the head from spraying water back onto the wall.

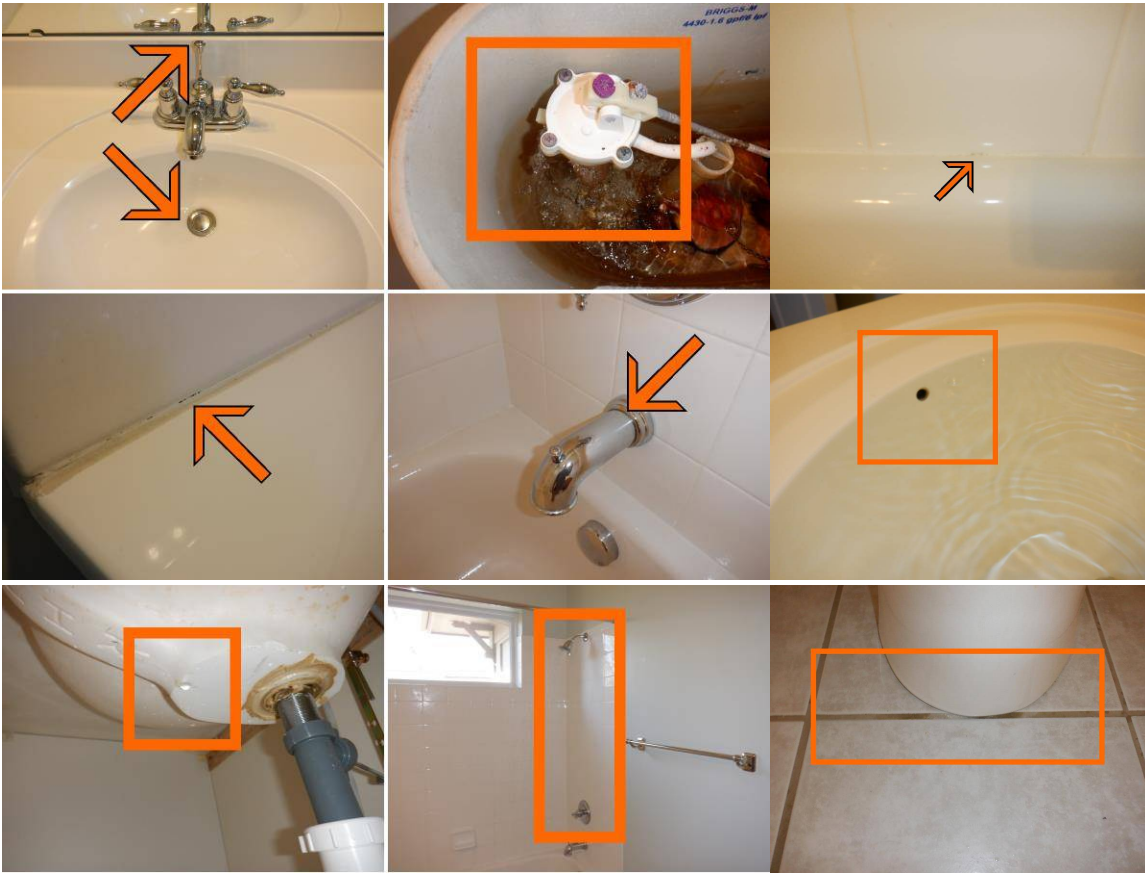
15. Due to the following but not limited to the listed items below, repairs and/or corrections are needed within the **upstairs hall bathroom area**. A qualified licensed contractor should be consulted to further evaluate and determine the full extent of the damage and/or if additional repairs are required or deemed necessary as there may be additional defects that were concealed and/or otherwise unseen at the time of the original inspection. Further evaluation is recommended before the close of escrow on the home to completely understand the extent of the damage(s) and the full extent of the repairs that are needed, required, or deemed necessary by the qualified licensed contractor.

- a)The sink stopper did not function properly at the time of inspection. When fully engaged water still drains. Correction is needed to allow proper operation.

- b)Caulk was needed to fill the gaps where the sink counter top and backsplash meet to prevent water penetration.
- c)The fill valve was bad and needs repair/replacement. Water should only exit through the rubber hose at the middle of the tank or down the provided pipe on the side depending on the type of fill valve you have. Water should not spray out around the top gasket of the valve this indicates a bad gasket and is not functioning properly, repair or replacement needed.

- d)The tub faucet was loose in the wall and needs to be secured properly to prevent movement and possible leakage behind the wall.
- e)Several areas in the tub/shower surround that were noted in need of additional grout or re-grouting to be sealed properly and prevent water penetration.

- g)There was an active leak noted in the overflow drain under the sink when the sink was filled and then tested. Correction is needed to prevent further leaking.

- h)There was a squealing noise when the shower was tested. This is typically a sign of an obstruction in the pipe. Correction is needed to prevent the noise during operation.

- i)There was staining on the grout at the base of the toilet. I was unable to determine the source of the staining. Continue to monitor for signs of leaking from under the toilet and make correction if needed.

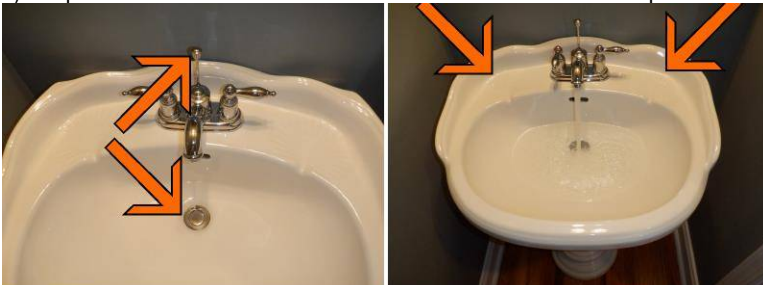
16. Due to the following (but not limited to) the listed items below, repairs and/or corrections are needed within the **1/2 bathroom area**. A qualified licensed contractor should be consulted to further evaluate and determine the full extent of the damage and/or if additional repairs are required or deemed necessary, as there may be additional defects that were concealed and/or otherwise unseen at the time of the original inspection. Further evaluation is recommended before the close of escrow on the home to completely understand the extent of the damage(s) and the full extent of the repairs that are needed, required, or deemed necessary by the qualified licensed contractor.

a) The sink stopper did not function properly at the time of inspection. When fully engaged water still drains. Correction is needed to allow proper operation.

b) The pedestal sink was loose at the floor or wall at the time of inspect and needs to be secured properly.

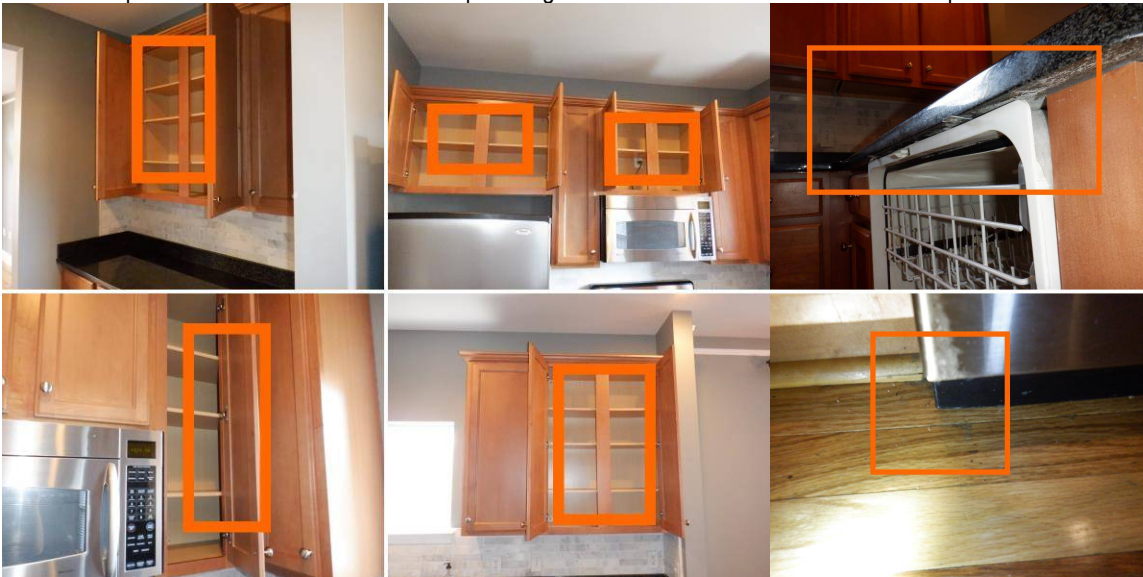
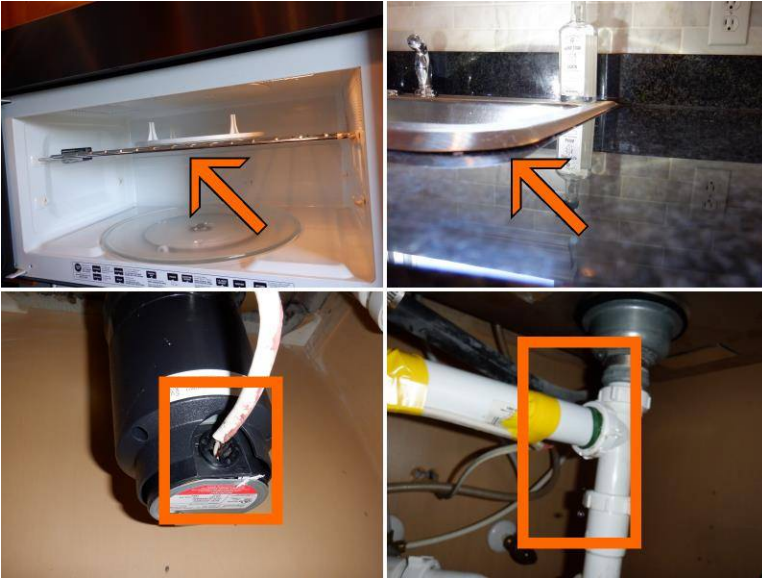
17. a) The following upper kitchen cabinets were missing the middle support brackets. These prevent the shelves from bowing under heavy loads.

b)The dishwasher was not attached or secured properly under the countertop and needs corrections. Corrections and/or repairs are needed so the dishwasher is secured properly to prevent possible movement.

c)There was a water stain on the wood floor under the left corner of the dishwasher door. No active leaking was noted during testing. Continue to monitor and make correction if needed.

d)The microwave had a metal rack that comes new with a sticker that reads " remove the rack during use in normal microwave mode and do not store the rack in the unit". Remove the rack and store it elsewhere to prevent a potential arc hazard.

e)The electrical clamp or cover plate was missing where the electrical wires enter the base of the disposal unit. The clamps or plates are needed to protect the wiring and need to be installed. Have a licensed/certified appliance repair person further evaluate and make any additional repairs as needed.

f)The sink was not tight to the counter. Correction is needed to prevent water intrusion under the sink.

g)There was an active leak at the drain connections under the sink on the pipe coming from the disposal. Water sprayed out of the connection when the disposal was tested. Have a licensed plumbing contractor further evaluate and make repairs as needed.
