Confidential Inspection Report Prepared For

933 Sample St.
Charlotte, NC 28204

March 29, 2019

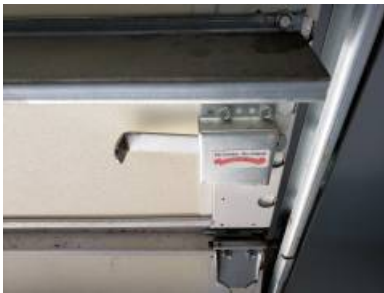
This home is equipped with an automatic garage door opener. It is recommend that the manual lock be removed to prevent possible damage to the garage door or opener. With the manual lock engaged it may cause damage to the garage door opener or garage door itself during operation. The garage door is locked automatically when the garage door opener closes the garage door.
